Channel Incision and Water-Table Decline Along a Recently Formed Proglacial Stream, Mendenhall Valley, Southeastern Alaska

Professional Paper 1760–E

By Edward G. Neal

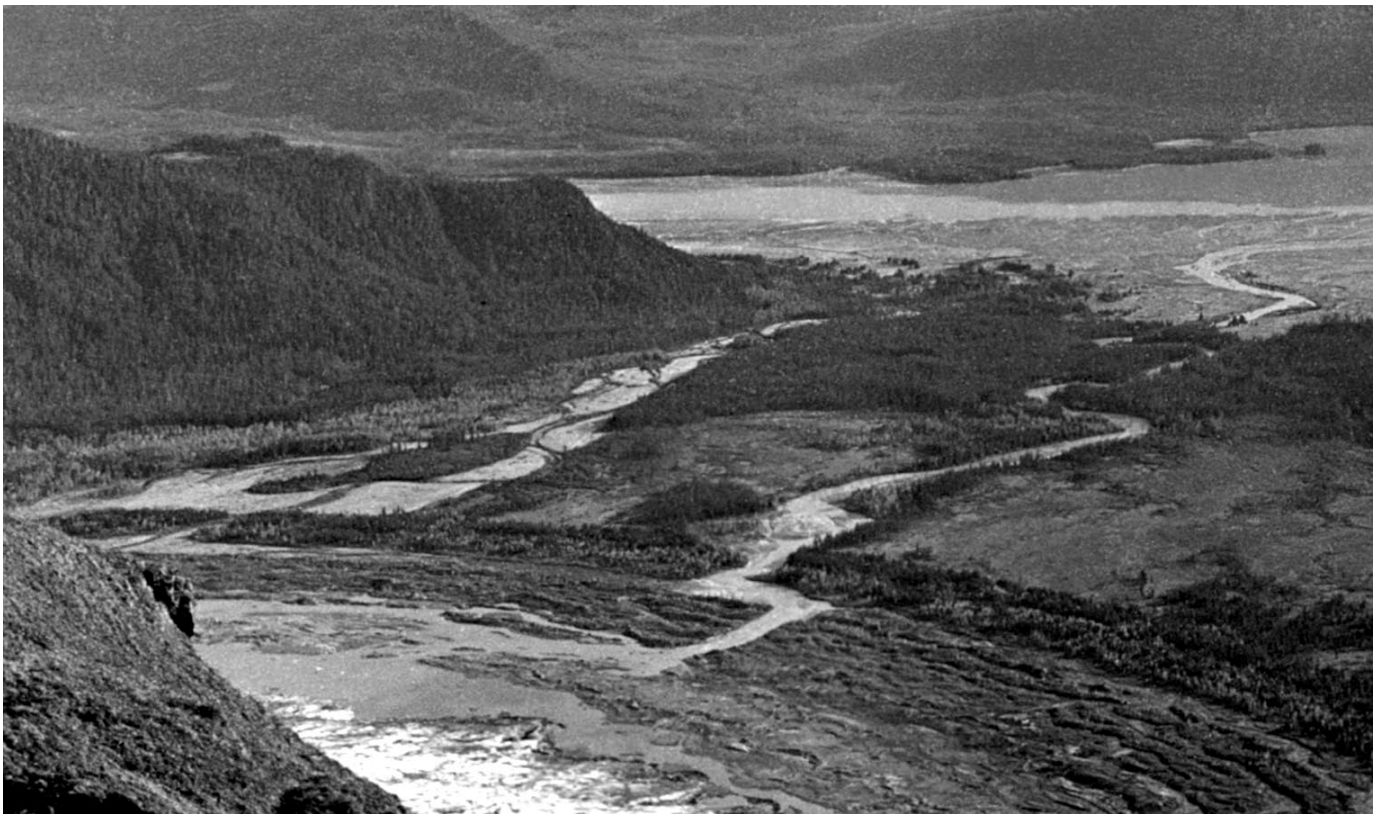
Figure 2. Historical photo of the Mendenhall Valley, southeastern Alaska, showing the Mendenhall River emerging from the Mendenhall Glacier and abandoned outwash channels on the eastern side of the Valley. (Photo by W. Ogilvie, 1893.)

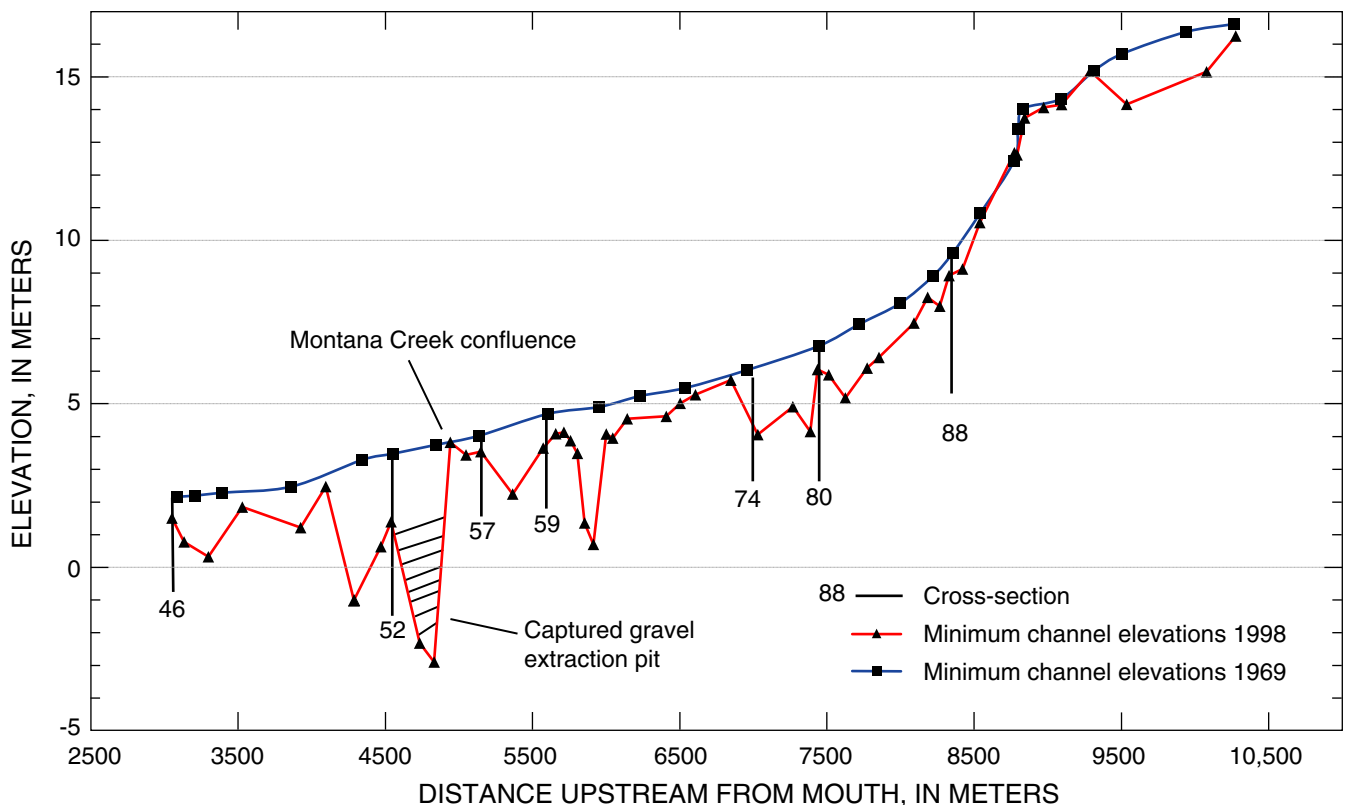
Figure 3. Longitudinal profile of Mendenhall River channel, southeastern Alaska, showing the minimum bed elevations and the locations of replicated cross sections surveyed in 1969 and 1998.

Channel incision of the Mendenhall River from 1969 to 1998 was variable throughout the study reach (fig. 3). Minimum bed elevations decreased by as much as 4 m in 2 locations, not including a captured gravel-extraction pit, yet showed little change at some locations within the study reach. Some of these differences may be attributed to the finer resolution of the 1998 surveys, which included 24 additional cross sections that further defined channel geometry at pools and bends. Changes in mean bed elevation at the seven channel cross sections surveyed at replicated locations in 1969 and 1998 ranged from -0.4 to -1.5 m, and changes in minimum bed elevation ranged from -0.3 to -2.1 m (table 1). Similarities in changes in minimum and mean bed elevation suggest reductions in minimum bed elevation approximate changes in mean bed elevation throughout the study reach. The average decrease in both minimum and mean bed elevation for all cross sections was 1 m. Assuming a constant rate of bed degradation; this decrease translates to a rate of -0.03 m/y.

The variability in channel incision since 1969 (fig. 3) appears to be controlled primarily by the ability of channel-bed material to resist erosion. For example, upstream from cross-section 88, the river has carved a path through a sequence of moraines. Bed materials through this reach consist predominantly of large boulders with diameters exceeding 3 m (fig. 9). The finer materials have winnowed away, armoring the channel and limiting incision, resulting in bed elevations that have remained stable during the 29-year period between surveys. Localized grade control due to channel armoring has limited channel incision on other streams (Leopold and others, 1964, Galay, 1983, and Williams and Wolman, 1984). Incision also appears to have been limited by erosion-resistant peat deposits (which had been buried by subsequent outwash

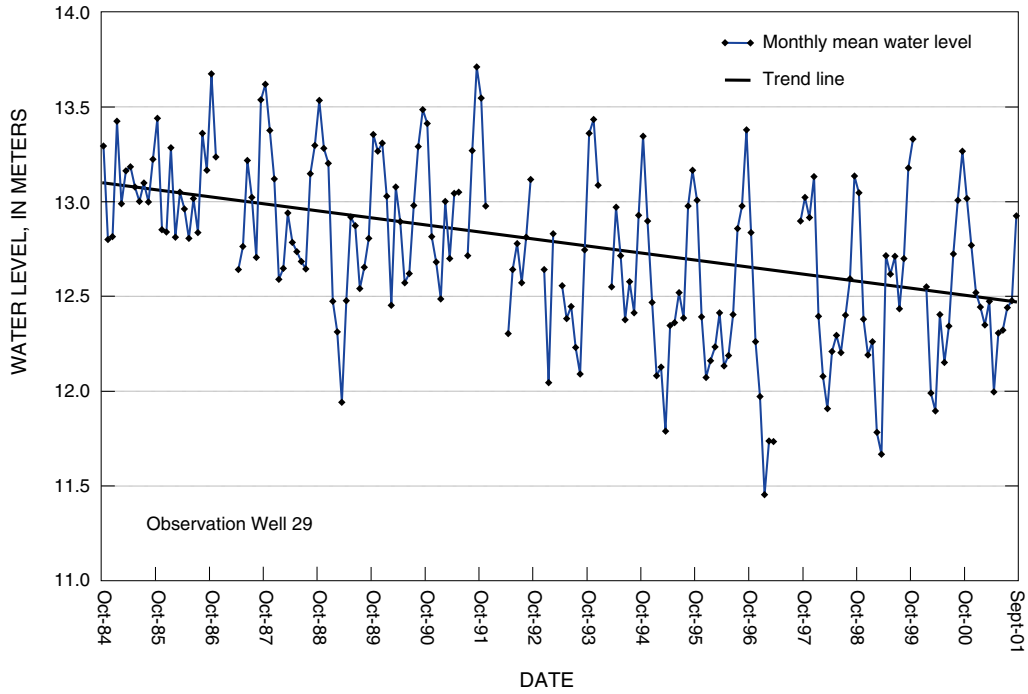
Figure 4. Monthly mean water levels recorded in observation well 29 from October 1984 through September 2001 illustrating the trend in declining water-table elevations, Mendenhall Valley, southeastern Alaska.

A linear declining trend in groundwater level was identified in data collected from 1984 through 2001 at observation well 29 (fig. 4). Because the water-level data exhibit large seasonal fluctuations, the Mann-Kendall seasonal test (Hirsch and others, 1982) was used to test for significance of the trend. This test is commonly used in hydrologic-data analysis (Helsel and Hirsch, 1992), and results indicated the trend in declining groundwater levels was statistically significant ($\alpha < 0.05$). The trend in declining groundwater levels in observation well 29 suggests a reduction in water table elevations of 0.6 m from 1984 to 2001 (0.03 m/y).

The trend in declining groundwater levels in well 29 (fig. 4) indicates a reduction in water-table elevations of 0.6 m from 1984 to 2001 (0.03 m/y). The groundwater level decline does not appear to be related to long-term trends in streamflow or precipitation. Trends in precipitation have increased slightly when measured over a similar time period (Motyka and others, 2002). Mendenhall River exhibited no trends in decreasing discharge when examined over the same time period.

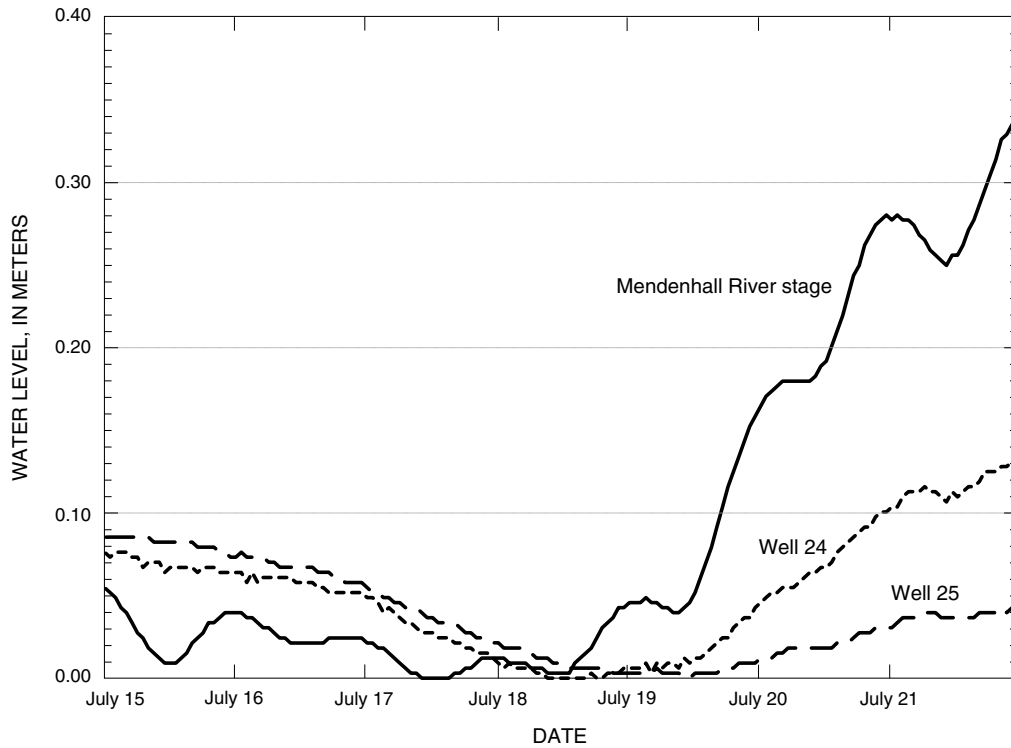
Figure 5. Plot showing changes in groundwater levels in observation wells 24 and 25 and Mendenhall River stage at the U.S. Geological Survey streamflow-gaging station from July 15-21, 2001, Mendenhall Valley, southeastern Alaska. Data were recorded during a period with no groundwater recharge from precipitation. Mendenhall River stage increase was due to enhanced glacial melt induced by temperature increases from July 18-21.

water-table elevation continues to rise throughout the warming event. The rise in water level in well 24 was about 40 percent of the rise in river stage, while the water-level rise in well 25 was about 15 percent of the rise in river stage. The total water-level response to stage increase may have been greater; however, the response is obscured by precipitation recharge the following day (July 22, 2001). Water levels were recorded in observation well 26 (fig. 1) during this event, and it demonstrated a response similar to that of well 25.

The rate of groundwater decline (0.03 m/y) is remarkably similar to estimated rates of channel incision documented from 1969 to 1998. Given the wells' proximity to the incised channel, coupled with the fact that surface water and groundwater are frequently connected in shallow aquifer systems; it appears that the decline in groundwater levels may be driven by channel incision. The hydrologic coupling of groundwater levels and Mendenhall River stage is further indicated by the rapid response of groundwater levels to stage increases during periods without groundwater recharge from precipitation (fig. 5).

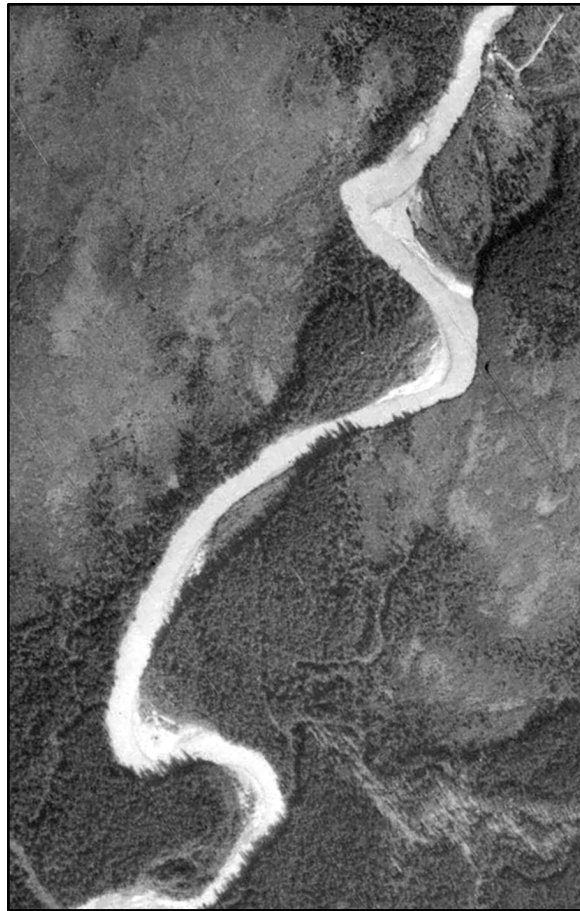
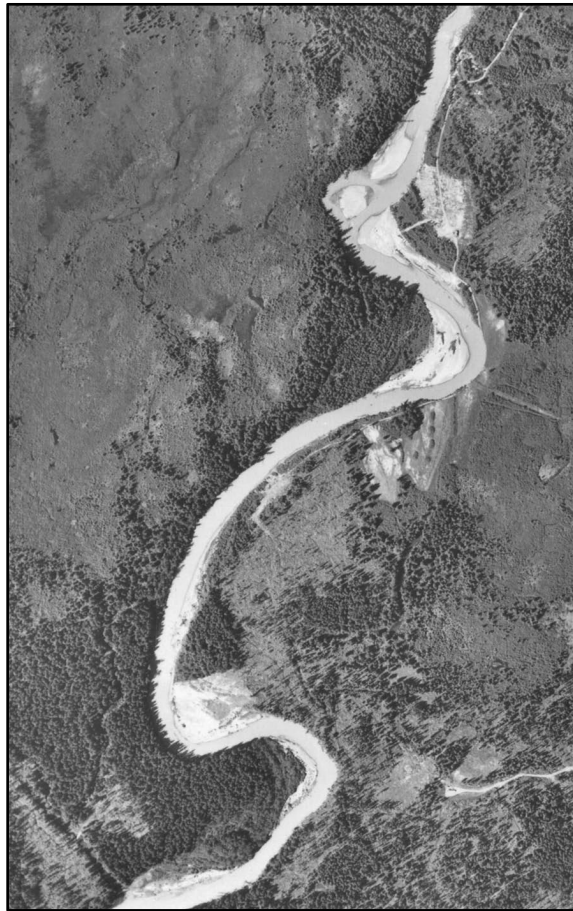
Figure 8. Aerial photos of the Mendenhall River channel, southeastern Alaska, from 1948 to 2005, showing a reduction in the number and size of gravel bars and colonization of points and bars by immature forest.

Evidence for Mendenhall River channel incision is not limited to repeat channel surveys. A series of aerial photos from 1948 through 2006 (fig. 8), indicate the channel configuration of the Mendenhall River has transitioned from a wider somewhat braided channel, more typical of a proglacial river

Aerial photos further revealed a gradual reduction in the number and size of gravel bars and the colonization of points, bars, and banks by immature spruce forest (fig. 8). A lack of flood plain definition provides additional evidence of an incising channel. The flood-profile model developed by Neal and Host (1999) showed that even 100-year flood flows will not overtop banks throughout the majority of the study reach, suggesting the top of the bank represents a terrace rather than a flood plain.

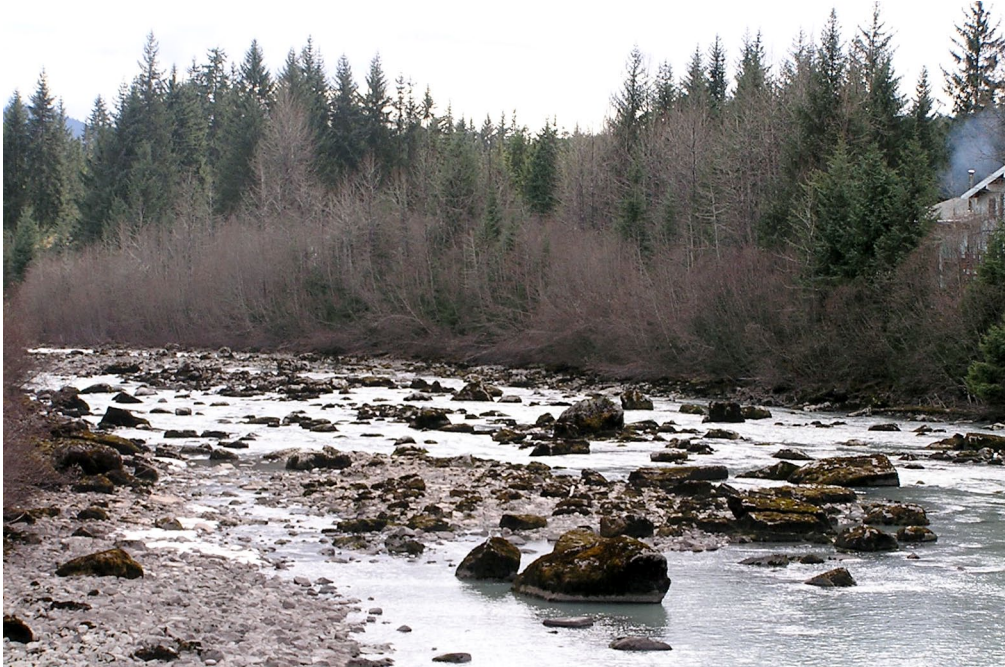
Figure 9. Photo of erosion resistant reach of the Mendenhall River, southeastern Alaska, showing the channel upstream of cross-section 88, where the river has incised through moraine deposits leaving large cobbles and boulders armouring the channel.

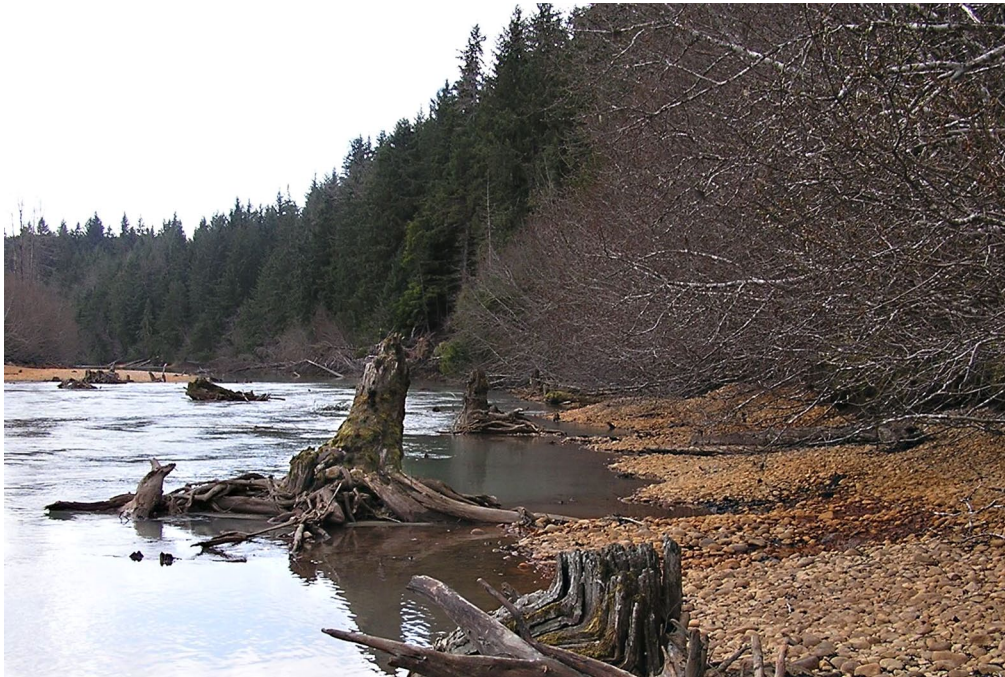
Figure 10. Photo of Mendenhall River, southeastern Alaska, showing a reach downstream of cross-section 74, where the river has incised through outwash deposits exposing a peat layer overlain by a veneer of cobbles and upright stumps and root structures.

deposits) between cross-sections 74 and 57 (figs. 1 and 3). Remnant root structures and trunks of trees remain upright and intact, lining the channel bed throughout a reach extending several hundred meters downstream from cross-section 74 (fig. 10). The peat deposits extend downstream to cross-section 57, although they are covered by a veneer of cobbles throughout much of the reach. Intermittent incision through the peat layers suggests they may eventually erode completely.

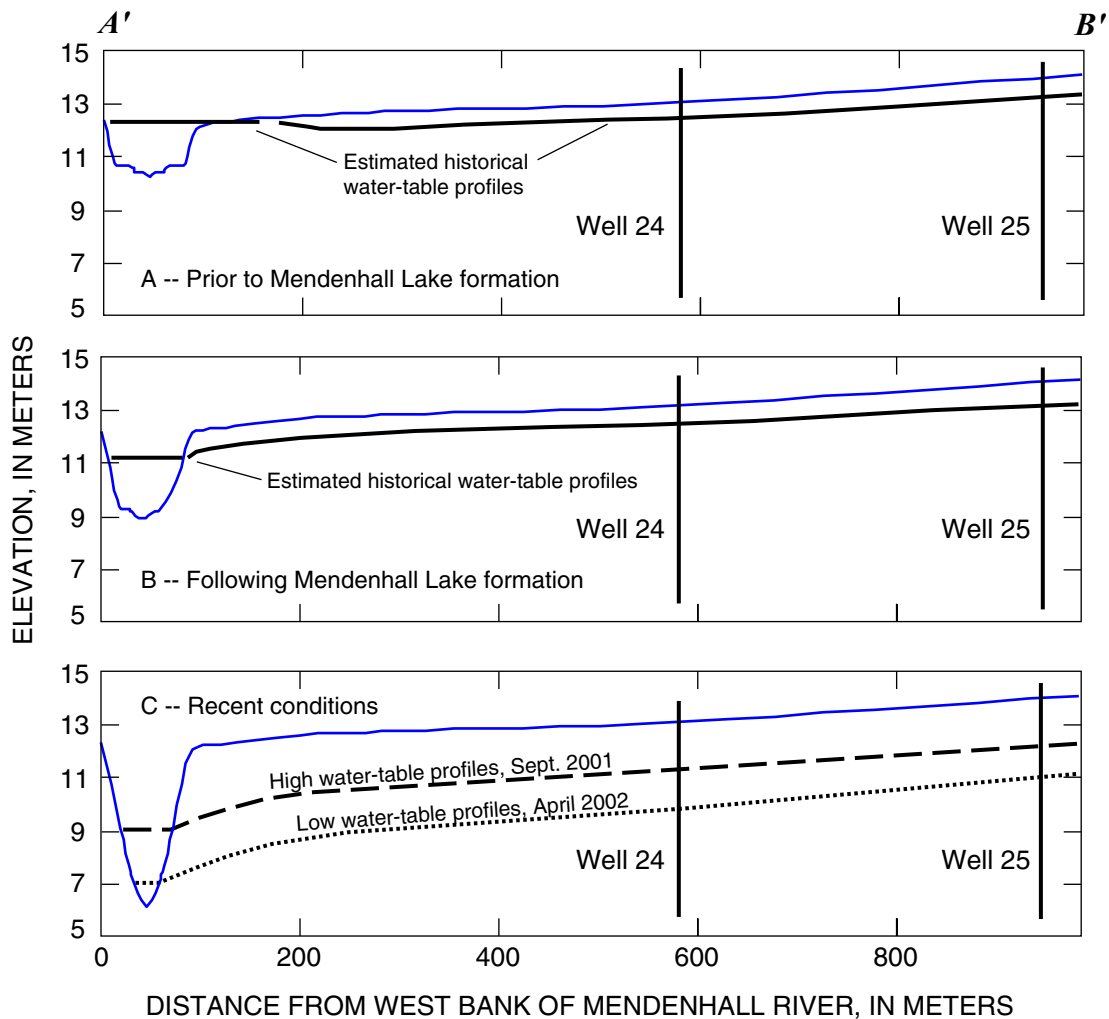
Figure 11. Cross sections showing inferred evolution of the Mendenhall River channel and adjacent water-table profiles over time at cross section A'-B' (see fig. 1), southeastern Alaska. A, Inferred historical channel and water-table conditions, prior to the formation of Mendenhall Lake, when the river channel was shallow and wider, and river stage during the runoff season was near the elevation of the valley floor. Mendenhall River water provided recharge to the shallow aquifer. B, Inferred historical channel and water-table profiles following lake formation and channel incision, over-bank stages decreased in frequency, and adjacent water-table elevations were elevated with respect to present conditions. C, Recent conditions illustrating additional channel incision and water-table elevations derived from channel surveys, Mendenhall River stage data, and water levels measured in observation wells 24 and 25. Discharges with 2-year recurrence intervals remain more than 2 m below top of bank.

tions, figure 11 illustrates a likely sequence of transitioning hydrologic conditions.

When the Mendenhall River channel first breached the terminal moraine and formed its current channel, stage elevations would have been near or at land surface providing recharge to the adjacent aquifer year round and maintaining water-table elevations that were near or at land surface (fig. 11A). Aerial photos from 1948 suggest that, prior to residential development on the east side of the Mendenhall River; the landscape in the vicinity of wells 24 and 25 was dominated by a mixture of forested wetlands and wetlands.
